RE: Request for Information (RFI) Pursuant to Section 308 of the Clean Water Act  
City of Albany Municipal Separate Storm Sewer System (NYR20A464)  
Docket No. CWA-IR-15-009

United States Environmental Protection Agency  
Washington, D.C. 20460  
**Water Compliance Inspection Report**

**Municipal Separate Storm Sewer System (MS4) Audit  
City of Albany (NYR20A464)  
June 3, 2014 through June 5, 2014**

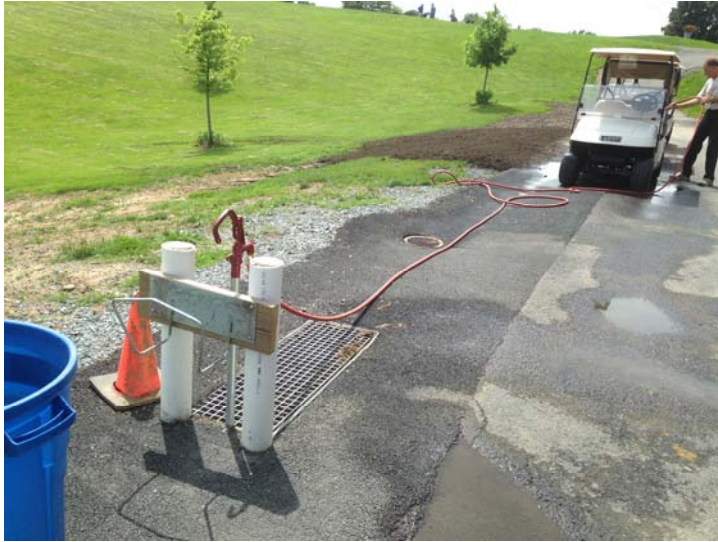
IMG\_0039.JPG – Golf cart rinsing location and adjacent catch basin at Golf Course

- e. At the Capital Hills Golf Course, cart and equipment rinse water, unroofed fueling pump, unroofed waste oil tank, soda can observed being emptied down drain, stockpile runoff, used oil containers lacking secondary containment in shop, all uphill from stormwater drainage structures (see photographs IMG\_0039.JPG, IMG\_0057.JPG, IMG\_0059.JPG, and IMG\_0071.JPG). Subsequent to the Audit, the City constructed a roof over the waste oil tank, reconstructed the roof of the shop, and put used oil containers on spill pallets.

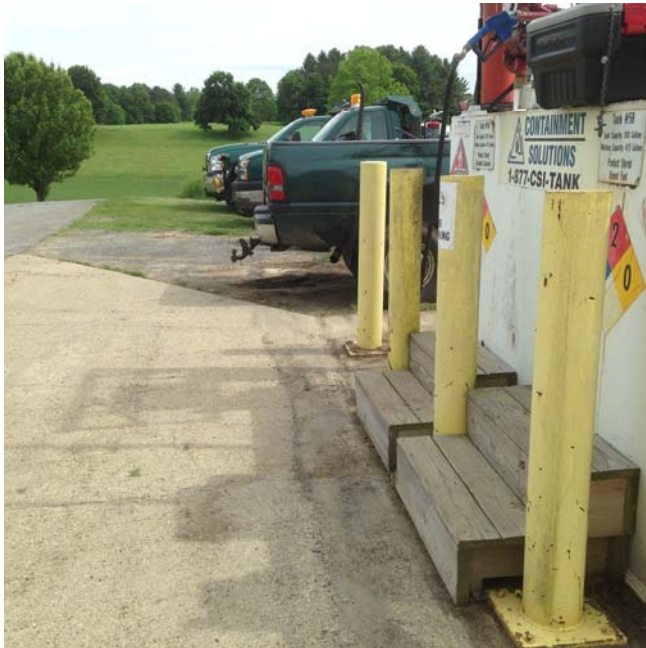
IMG\_0057.JPG – Vehicle fueling station at Golf Course

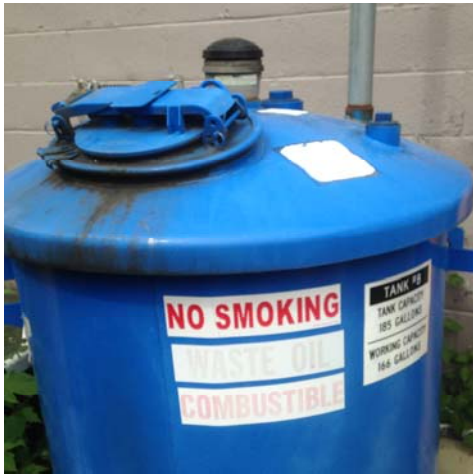
IMG\_0059.JPG – Waste Oil container at Golf Course maintenance area

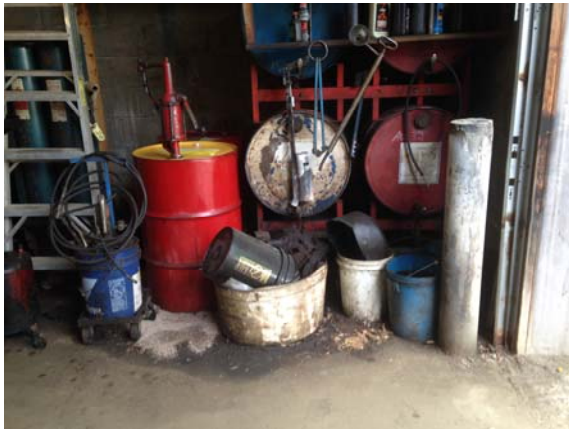
IMG\_0071.JPG – Fuel and other containers without secondary containment in maintenance garage at Golf Course, dark staining observed on the floor

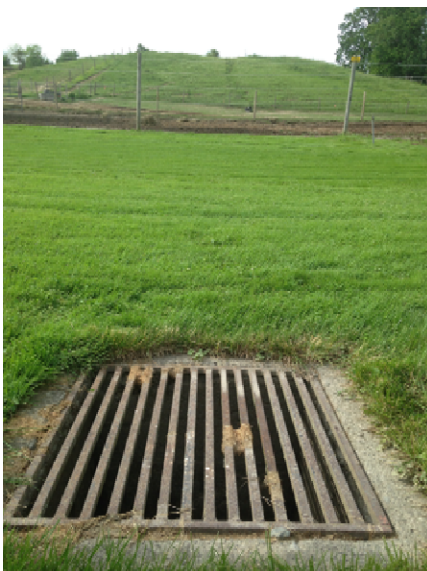
IMG\_0081.JPG – Catch basin downhill from the barnyard at the Normanskill Farm

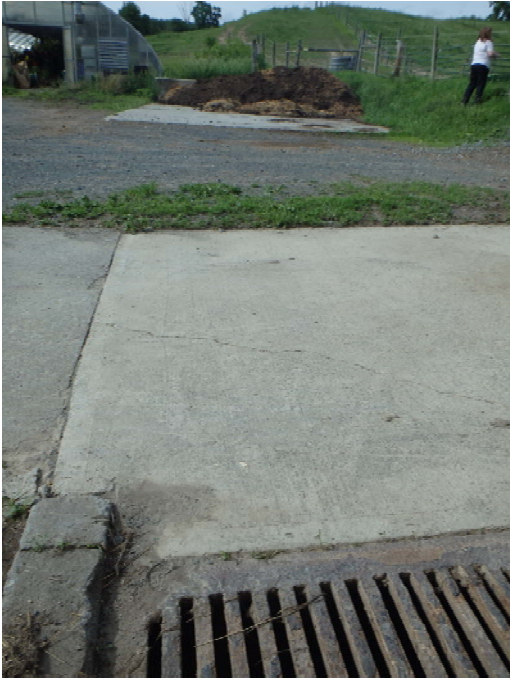
P6040102.JPG – Trench drain downhill from manure storage pile at the Normanskill Farm

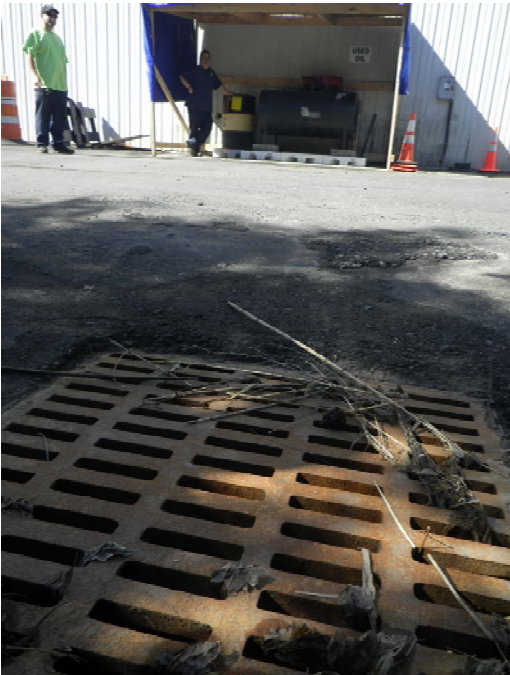
RIMG0032.JPG – Catch basin downhill from the waste oil container at the Water Department

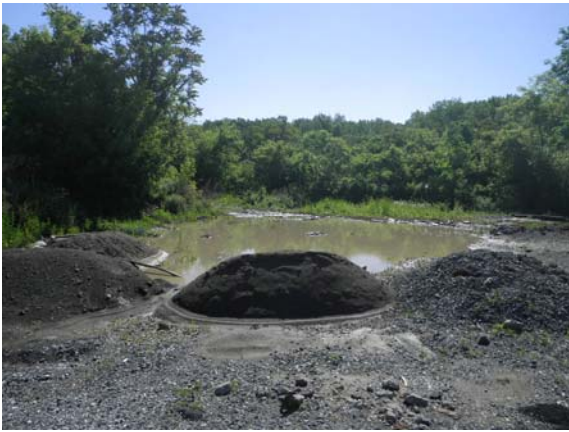
- a. At the Water Department facility, EPA inspectors observed waste in the stock pile area in an unpaved portion outside (see photograph RIMG0037.JPG); and

RIMG0037.JPG – Stock piles and ponding water behind the Water Department

8. EPA inspectors observed locations described below owned and operated by the City that contribute or potentially contribute pollutants to the soil and/or groundwater. The City should implement good housekeeping practices that ensure that the groundwater is not contaminated at City facilities by preventing pollutants from entering the ground and by cleaning up spilled material as well as ensure that vegetation and barriers are maintained to prevent these locations from discharging to surface water:

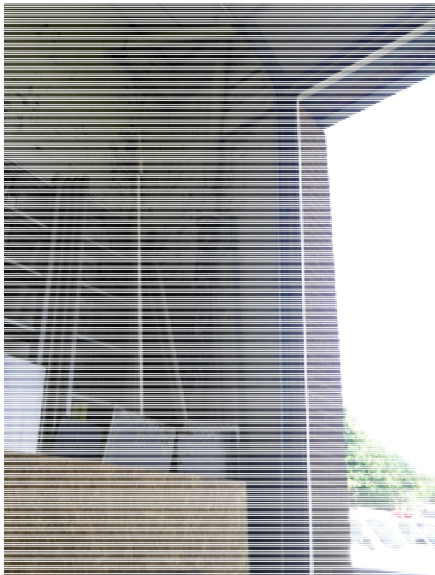
RIMG0058.JPG – Roof drain pipe connected internally to the floor drains and sanitary sewer line at the Fire Department repair shop off Erie Blvd

10. According to City representatives and observations at the time of the Audit, stormwater from the roof at the Albany Fire Department Repair Shop is connected via pipes to the floor drains and then combines with the sanitary from the bathroom and then enters the sanitary sewer system (see photograph RIMG0058.JPG). According to City representatives, the floor drains back up when it rains. At the time of the Audit, EPA inspectors observed oil stains on the floor of the garage. Stormwater entering the sanitary sewer system is a source of inflow and reduces capacity of the system for conveying sanitary sewage during rain events. Additionally, flooding in the garage could potentially carry oil and other pollutants on the floor of the garage down the driveway and to the MS4. The City should evaluate disconnecting the roof drains from the sanitary sewers.

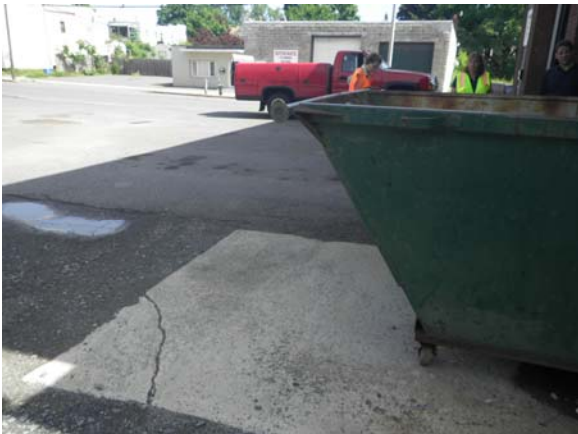
- b. At the Albany Fire Department Repair Shop, an uncovered dumpster outside containing waste and leaking uphill from an unprotected catch basin (see photograph RIMG0062.JPG);

RIMG0062.JPG – Uncovered dumpster uphill from catch basin in the road at the Fire Department repair shop off Erie Boulevard

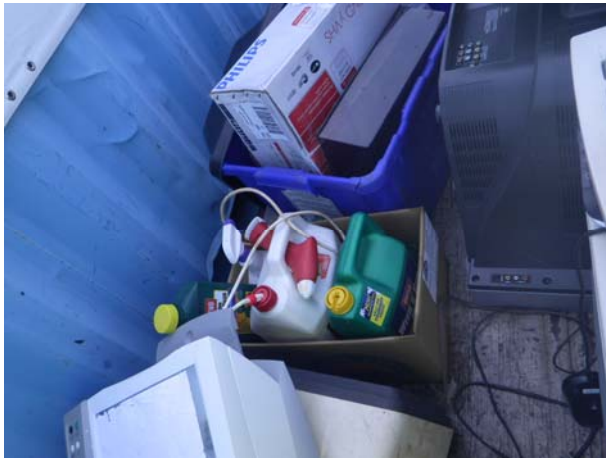
9. At the time of the Audit, EPA inspector McEathron observed hazardous waste, including pesticides at the electronic waste drop off location at the Department of General Services Facility (RIMG0074.JPG). The e-waste collection area is located uphill from catch basins at the base of the driveway. City of Albany representatives, removed the hazardous waste at the time of the Audit for proper disposal. According to City representatives, this location is monitoring on an at least daily basis to ensure that electronics that are dropped off are stored in the locked bin and any other types of waste are picked up and disposed of properly. The City should ensure that any waste at this location is not exposed to stormwater.

RIMG0074.JPG – Hazardous liquids including pesticides at the electronics pick up station at the Department of General Services

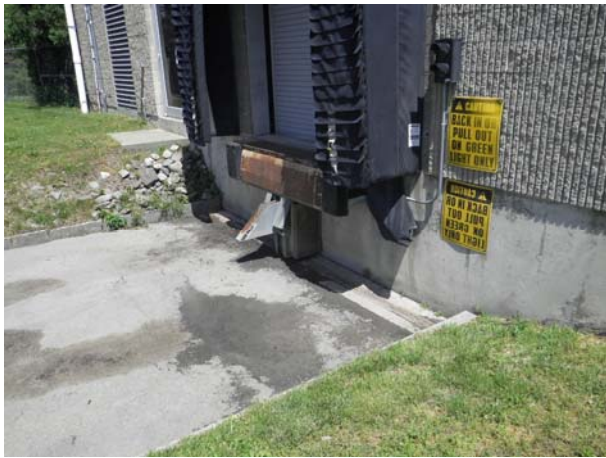
RIMG0091.JPG – Trench Drain at the Department of General Services loading area

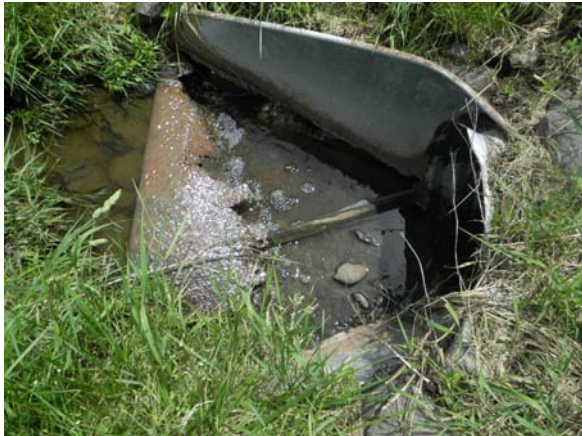
- d. At the Composting Facility, EPA inspector McEathron observed brown water in a drainage ditch connected to the MS4 immediately downhill from the compost piles, at the time of the Audit (see photographs RIMG0103.JPG, RIMG0105.JPG, and RIMG0109). Subsequent to the Audit, the City moved the shed, jersey barriers and silt fencing to provide a continuous boundary between the compost piles and the drainage ditch; and

RIMG0103.JPG – Dark brown water and foam flowing from the drainage ditch and into a pipe connected to the MS4

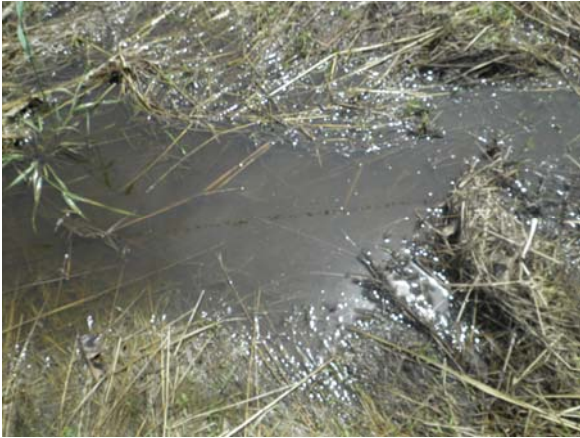
RIMG0105.JPG – Dark brown water in the drainage ditch adjacent to the Composting Facility

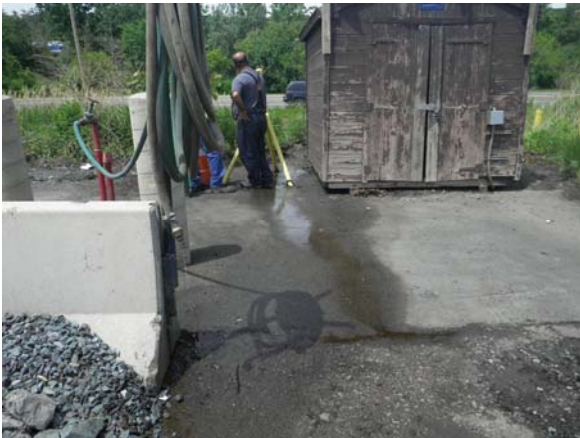
RIMG0109.JPG – Hose water and stormwater runoff location for composting area to drainage ditch, adjacent to the DGS Facility
